# Minnesota State

## 1. HEAPR

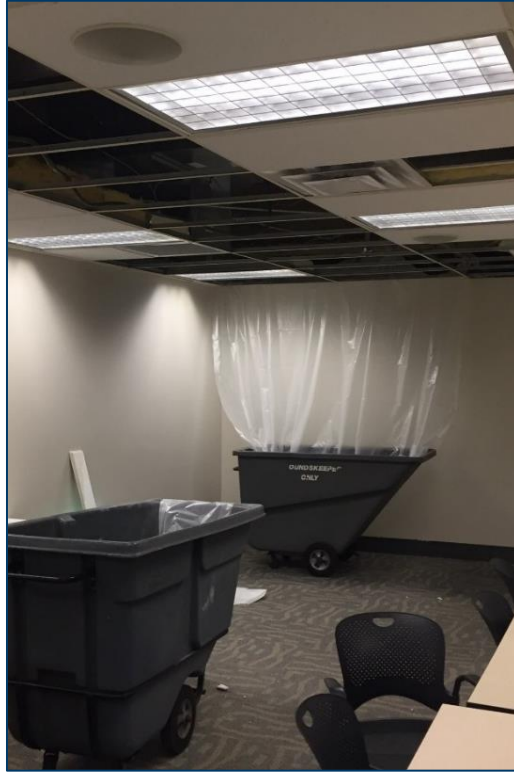
Minneapolis Community and Technical College – ceiling tiles with water damage have been removed

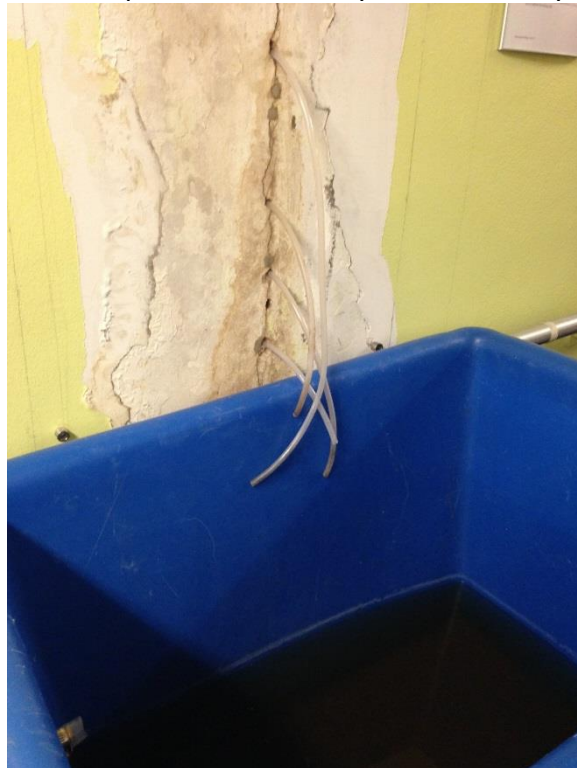
Normandale – crack in pedestrian hallway wall caused by ceiling leak

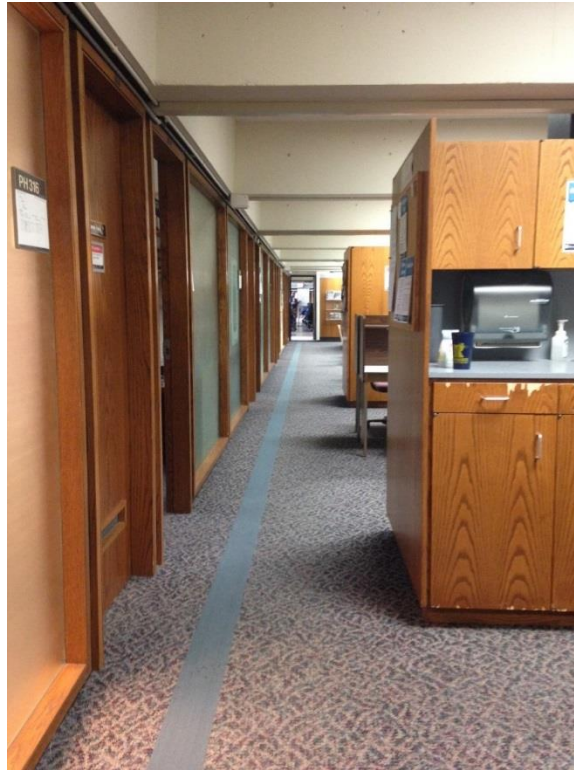
Outdated office space

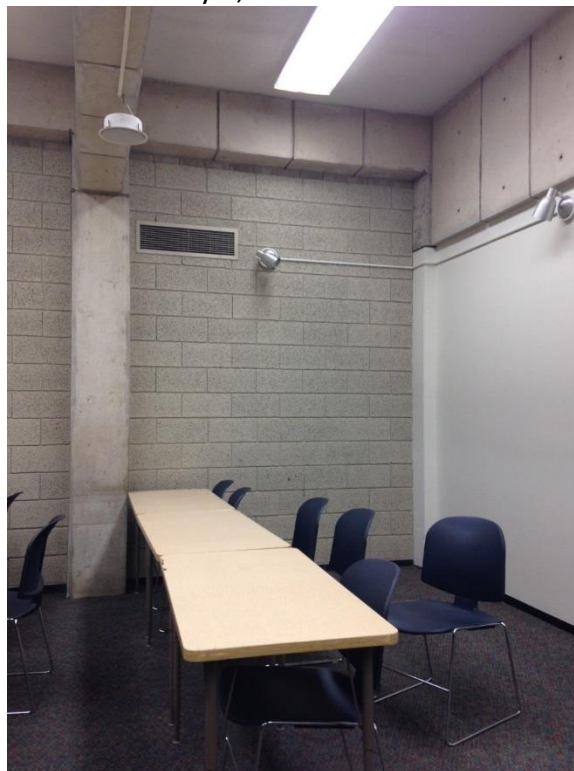
Lecture-style, inflexible classrooms

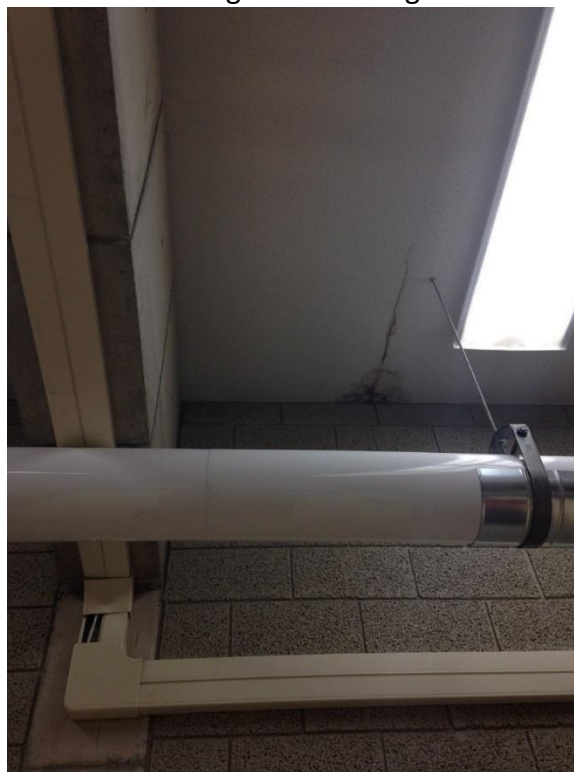
Ceiling water damage

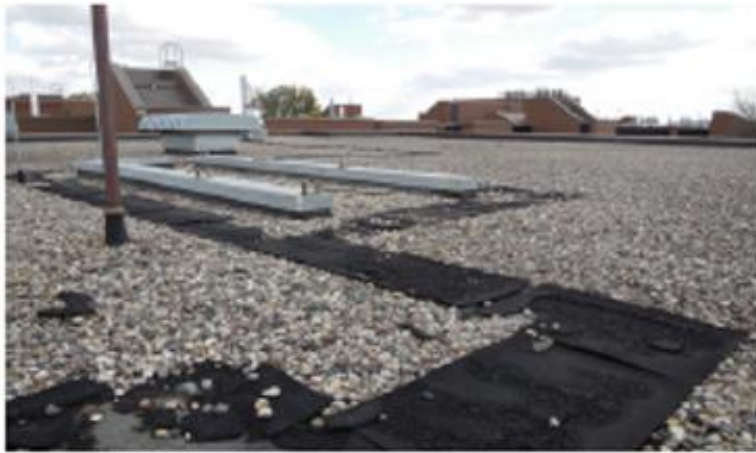
### Roof replacement – Wissink Hall

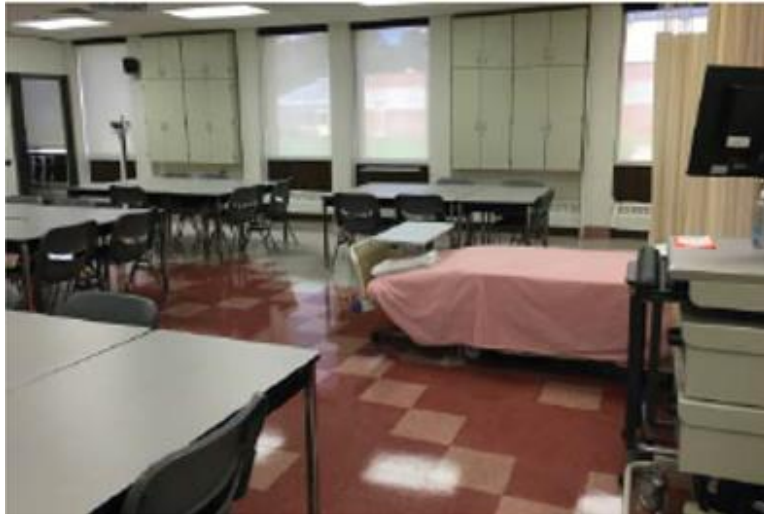
Outdated Nursing demonstration classroom

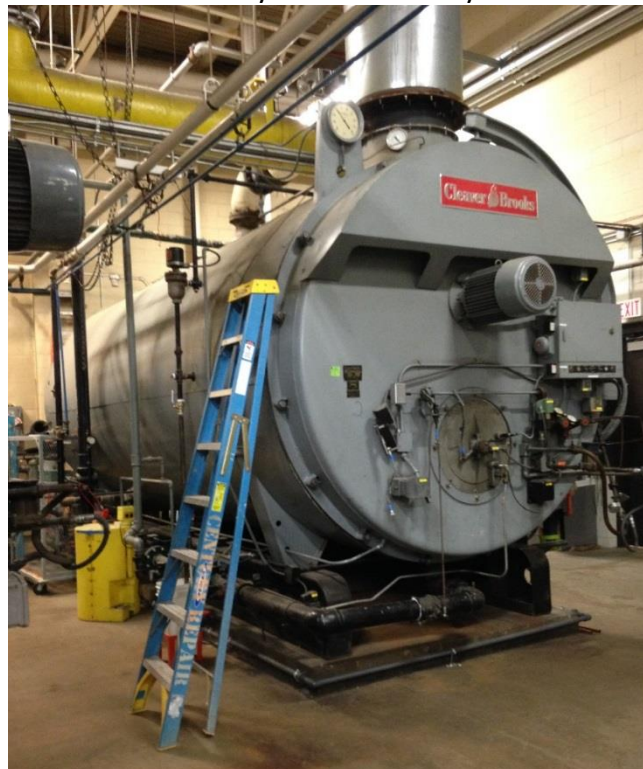
50 year old boiler system

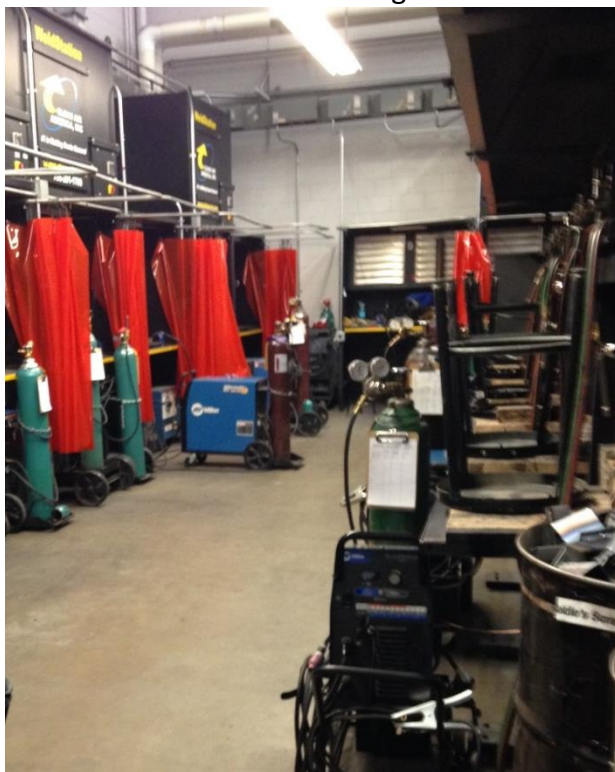
Outdated welding lab

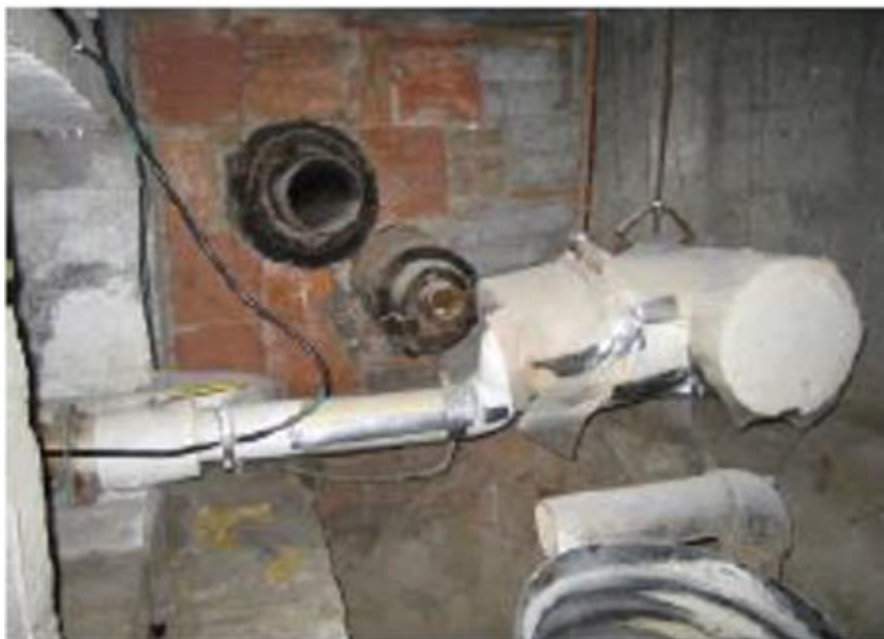
Renew piping

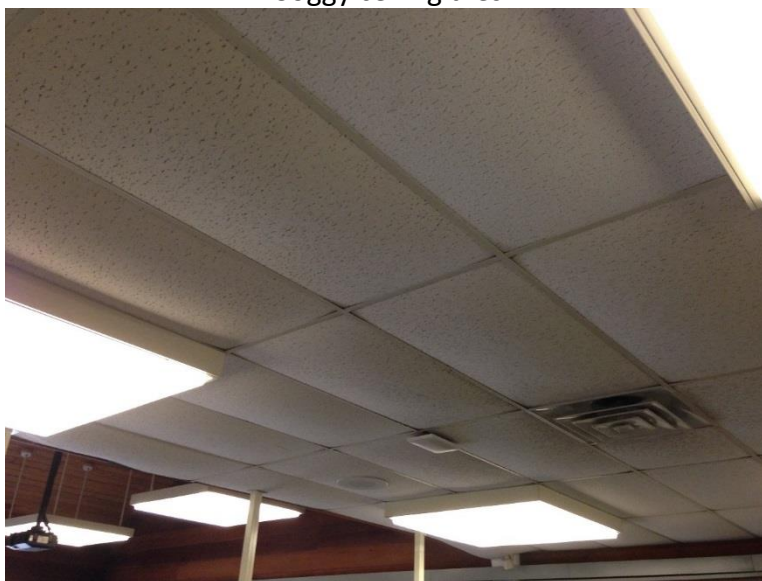
Soggy ceiling tiles

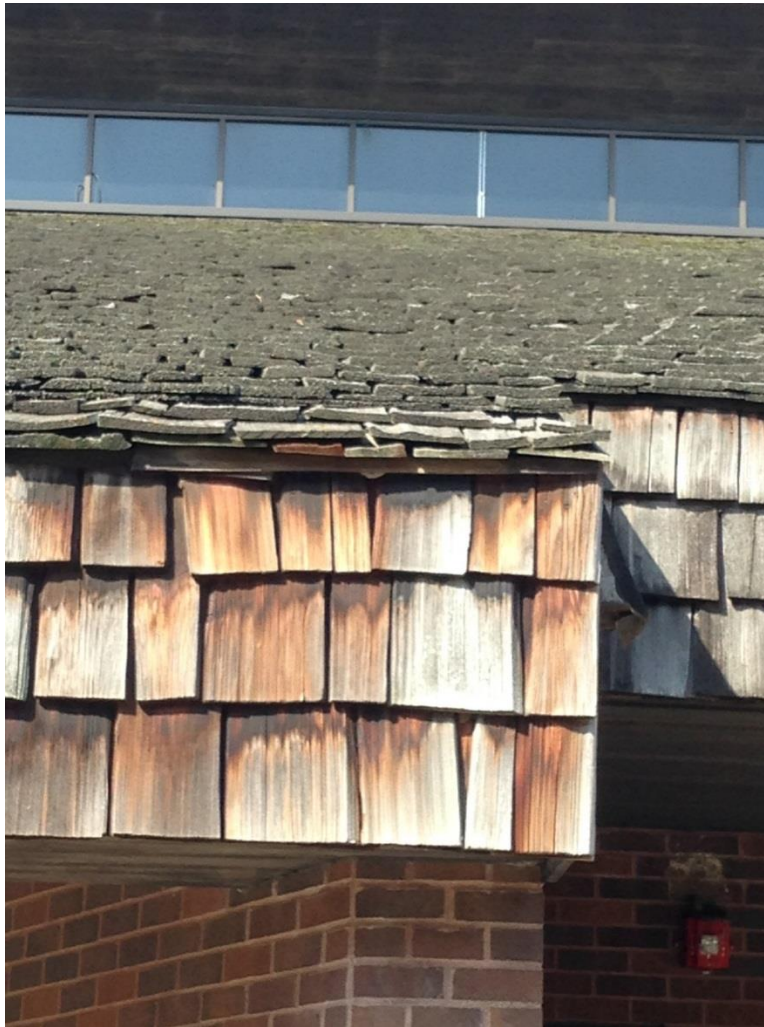
Roof needs to be replaced – shingles fall off daily

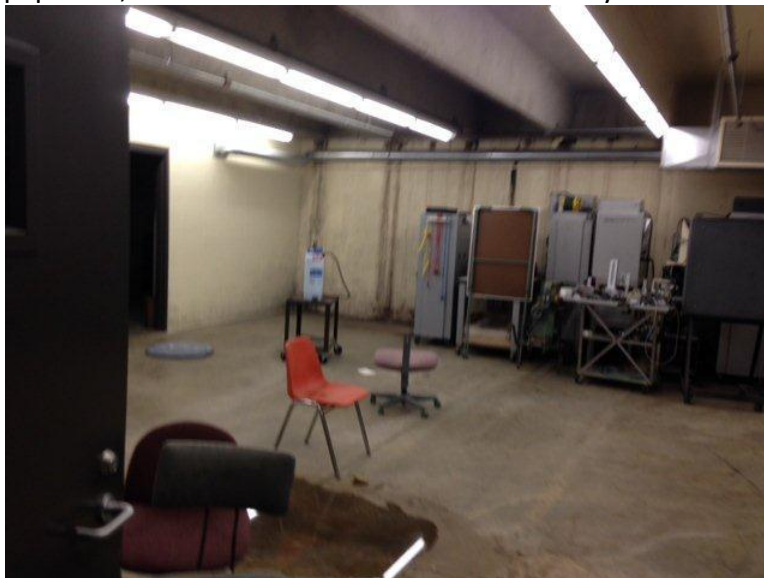
Pipe lab – outdated equipment, has been vacated due to accessibility and water filtration issues

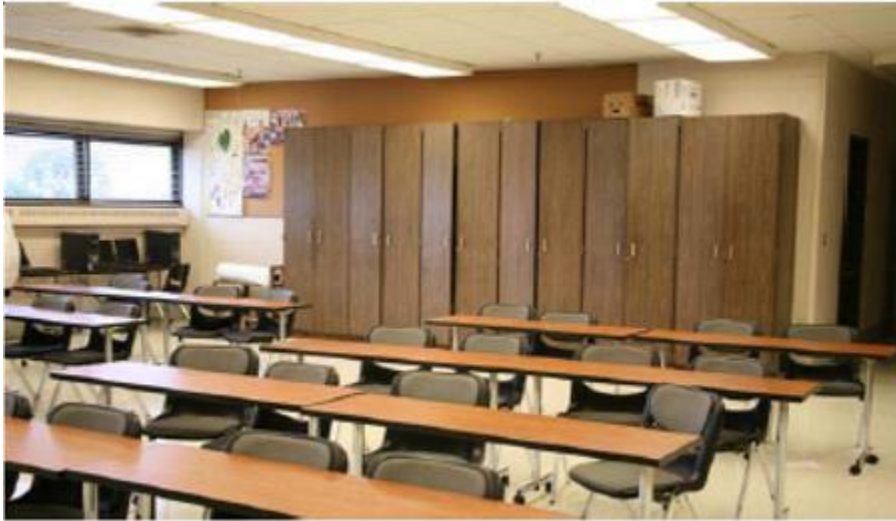
#### Outdated classroom

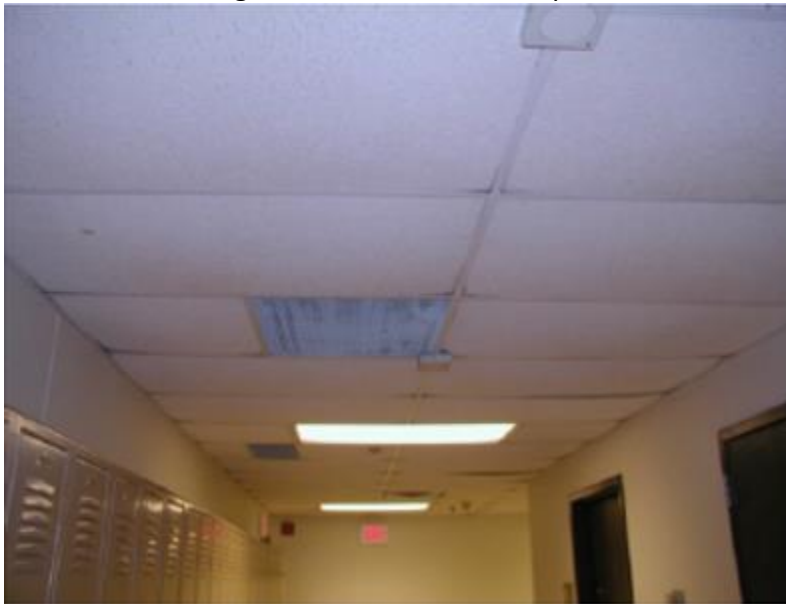
#### Ceiling tiles that need to be replaced

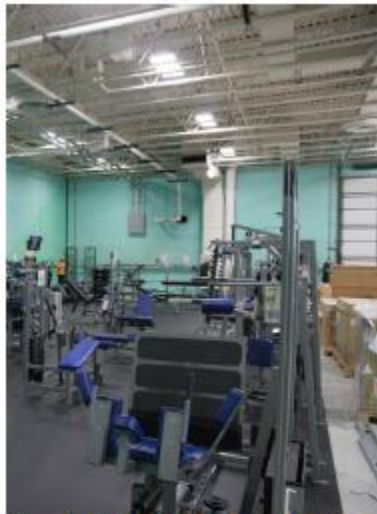
*View looking East at existing Fitness Center RM 305. The Fitness Center does not require the full RM 305 Space. Rm 305 was designated in the Master Plan Update to be preserved for future (adjacent) program space.*

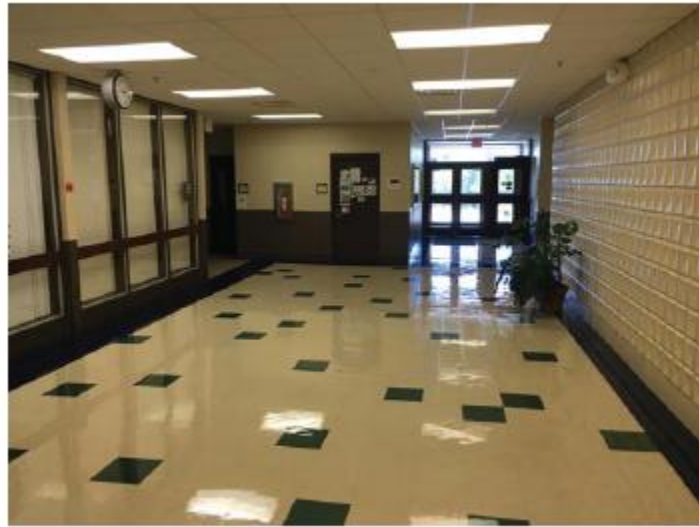
The main entry hall to the Classroom Building has had not significant improvements since 1971. The materials with the VCT flooring and acoustic tile ceiling are not good finishes for a major entry to the campus.

This predesign proposes to improve the material finishes that are visually more pleasing and require less maintenance.
